Operation, Maintenance, and Inspection  
Manual and Emergency Action Plan for  
Lake Lakengren Dam  
Preble County, Ohio  
ODNR File Number; 9545-001

Report No. 113063-0203-063  
March, 2003

Emergency Notification Procedure for  
 LAKE LAKENGREN DAM  
 File Number: 9545-001

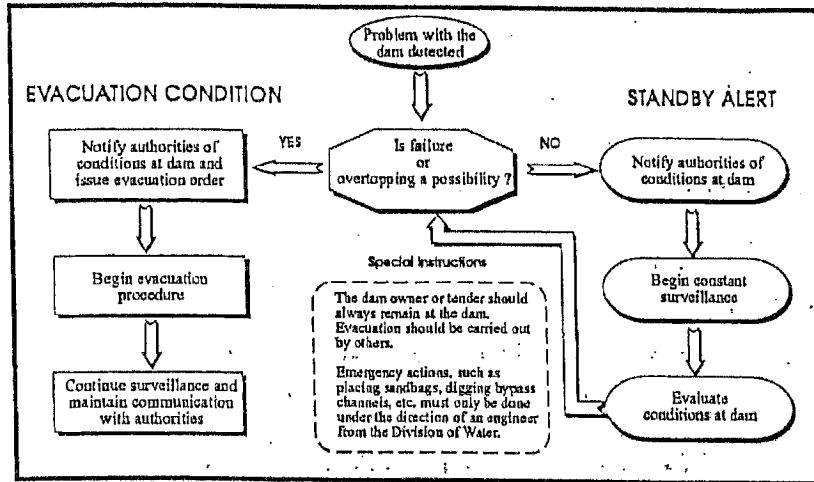
1) NOTIFICATION CHART

EAP COORDINATOR SHALL MAKE THE FOLLOWING NOTIFICATIONS

| EMERGENCY CLASSIFICATION LEVELS | | |
|---|--|--|
| <b>STANDBY ALERT</b> | <p>A situation where dam failure may occur, but preplanned actions may prevent the failure.</p> <p><u>Examples</u></p> <p>The lake level rising within 2.4 feet of the dam crest and continuing to rise.</p> <p>Seepage and piping of soil from the downstream slope</p> <p>Significant seepage flow on down stream slope that is not increasing with time.</p> <p>Embankment soil sloughing, soil cracks, soil erosion, or other soil movements indicative of slope instability during <b>flood</b> events.</p> | <p>Implement Emergency Notification Procedure</p> <p>(See Notification Chart – Section I)</p> |

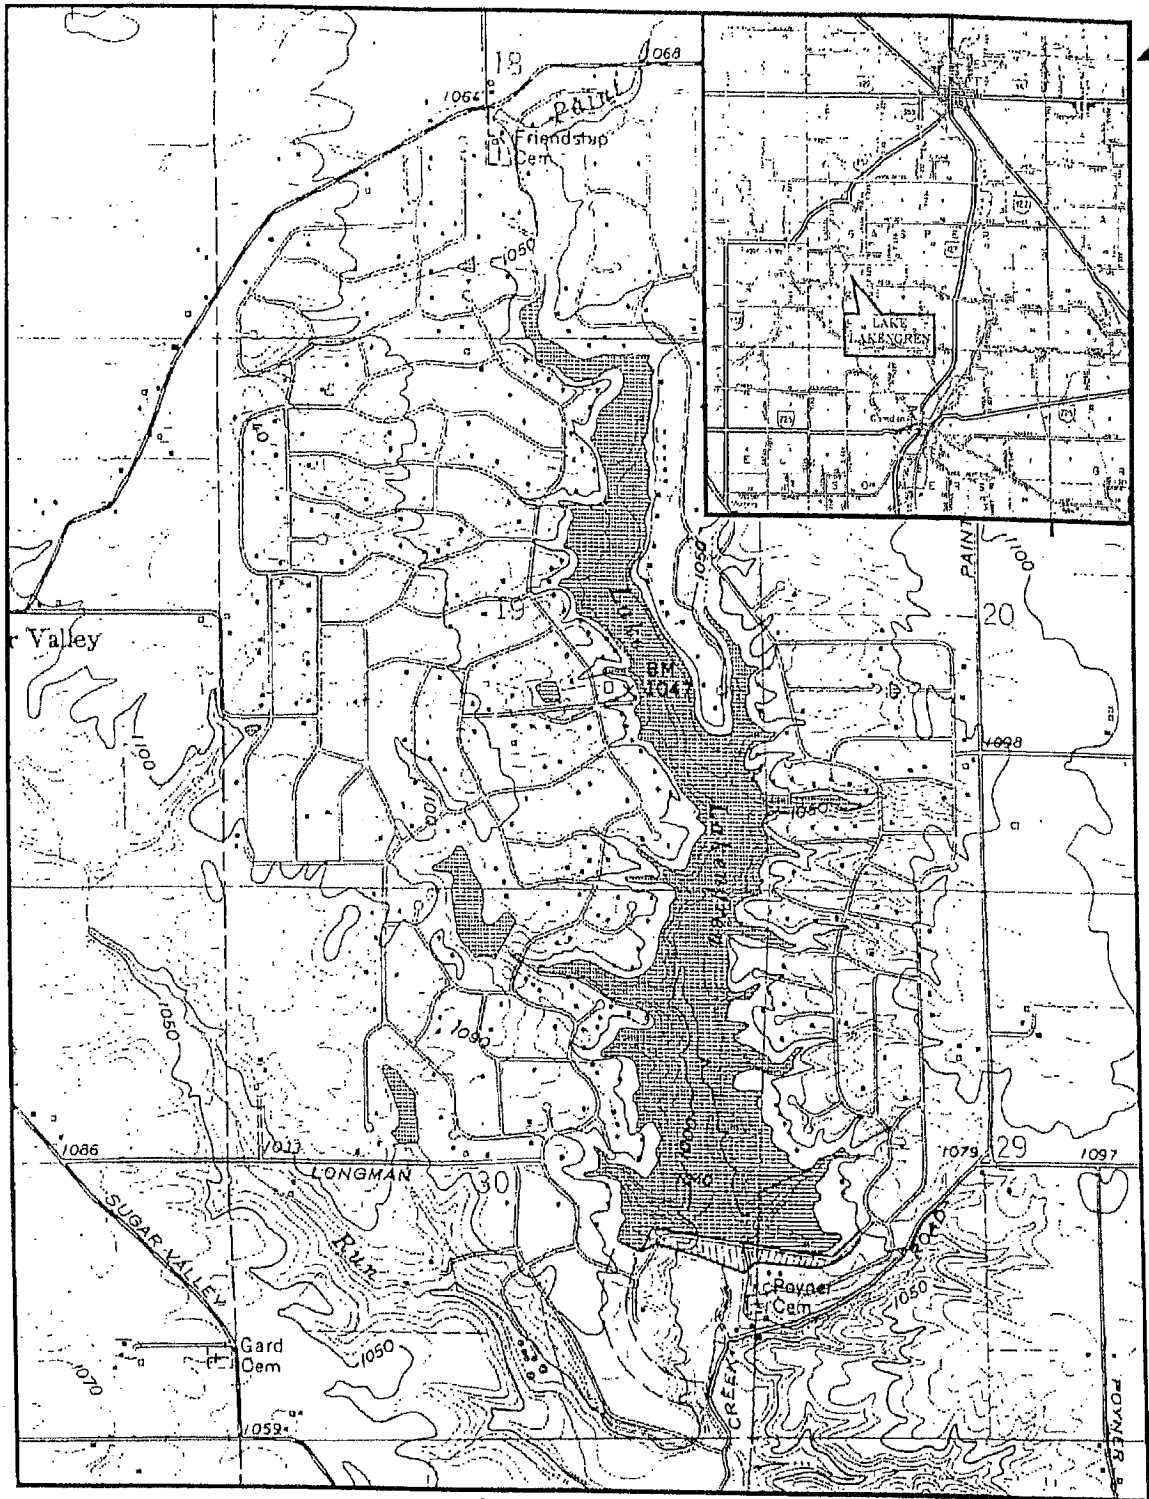
### VICINITY MAP

U.S.G.S. QUAD: EATON SOUTH, OHIO
